FIRE RESISTANCE TEST OF BUILDING ELEMENTS

TEST REPORT n° 09 – U – 170

A load-bearing steel-reinforced alleviated concrete wall reference "STRUCTURE JK", thickness is 120 mm covered on one side by facing and on the other side by a plasterboard BA 13.

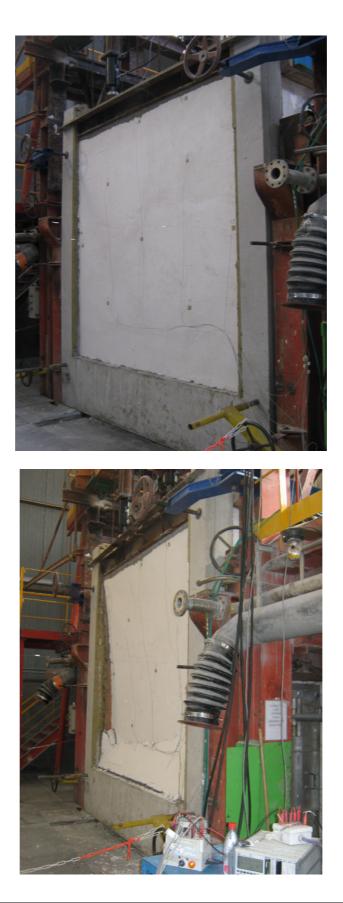
Time [min]	Face*	OBSERVATIONS
-15		Loading of the wall : 50 kN/ml. Nothing to report.
00	US	Start of the test.
		Vertical cracking at the top.
6	ES and US	Changing of the load's value : 25 kN/ml.
13	US	Smoke release at the cracking.
15	ES and US	Nothing to report.
20	ES	Cracking of the plasterboards.
22	ES	Falling down of parts of plasterboards in the middle of the wall.
30	ES and US	Nothing to report.
45	ES and US	Nothing to report.
60	ES and US	Nothing to report.
90	ES and US	Nothing to report.
110	ES and US	The subsidence speed limit of 9 mm/min is reached.
111	ES and US	The subsidence limit of 30 mm is reached.
		Falling down of facing and increase of the horizontal bending.
112	ES and US	Breaking of the wall, on the whole width, at 500 mm of the lower part. See Photo B. Termination of the test.

Duration	: ONE HUNDRED AND TEN MINUTES - (110 min)
Cause of failure	: Reach of the subsidence speed limit of 9 mm/min
10.2 ETANCHEITE AU FEU	
10.2.1 Tampon de coton	
Duration	: ONE HUNDRED AND TEN MINUTES - (110 min)
Cause of failure	: Lost of the load-bearing capacity criteria.
10.2.2 Calibres d'ouverture	
Duration	: ONE HUNDRED AND TEN MINUTES - (110 min)
Cause of failure	: Lost of the load-bearing capacity criteria.
10.2.3 Inflammation soutenue	
Duration	: ONE HUNDRED AND TEN MINUTES - (110 min)
Cause of failure	: Lost of the load-bearing capacity criteria.
10.3 ISOLATION THERMIQUE	
Duration	: ONE HUNDRED AND TEN MINUTES - (110 min)
Cause of failure	: Lost of the load-bearing capacity criteria.

Photo A(up)Unexposed side before the testPhoto B(down)Breaking of the wall (112th minute).
